**Flood Control Project Maintenance
Levee Inspections**
LMA District Cover Sheet
Spring 2018 Levee Inspection Results

Sutter Maintenance Yard Maintenance Area 0017

Levee Inspection Report By Mile - Spring 2018

Waterway	Bank	Unit Miles	Inspection Start/End	Inspector
Unit No. 01 Lake County Sutter Maintenance Yard - Middle Creek	Left	3.87	04/11/2018 04/11/2018	Bob Duffey

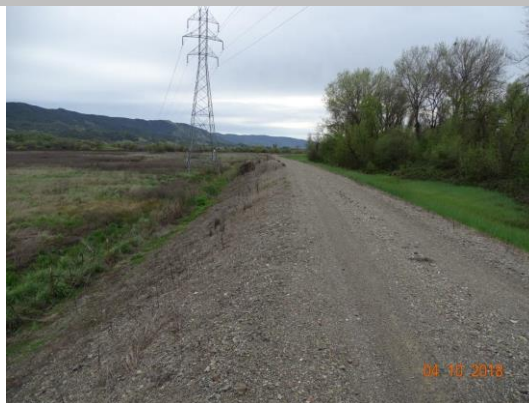
Photo 1 of 1 : SP_2018_MA0017_339_26_20180416_00044.jpg

LM Start	3.60	Rating **	A	Issue No.	26
LM End	3.60	Issue Type +	Ma	Location *	LS
Category	Earthen Levee			GPS Latitude/Longitude	
				Start	End
Item	Vegetation			39.146885 °	39.146885 °
				-122.909932 °	-122.909932 °
DWR ID	DWR_MA0017_01_s_2018_26				
Comment Code					
V1 : Control annual grass and weeds on the levee slopes and easements.					
Inspector Comment					
The vegetation has been removed from the landside slope.

View of the levee with no vegetation on the landside slope.

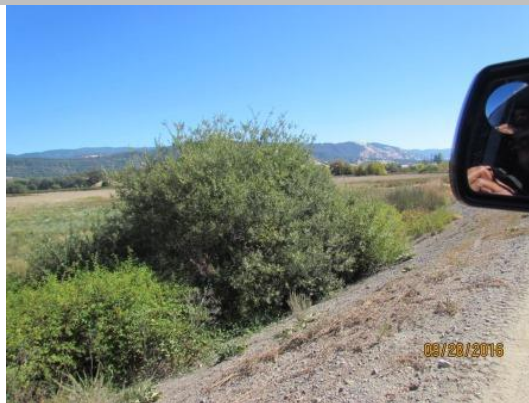
Photo 1 of 1 : SP_2018_MA0017_339_15_20180305_00003.jpg

LM Start	3.81	Rating **	M	Issue No.	15
LM End	3.84	Issue Type +	Ma	Location *	LS
Category	Earthen Levee			GPS Latitude/Longitude	
				Start	End
Item	Vegetation			39.144980 °	39.144620 °
				-122.907073 °	-122.906546 °
DWR ID	DWR_MA0017_01_s_2016_15				
Comment Code					
V2 : Remove the wild growth other than native grasses from the levee slopes.					
Inspector Comment					
Large bushes and brambles covering wire fence, limiting visibility and access.

View of the large bushes limiting visibility and access.

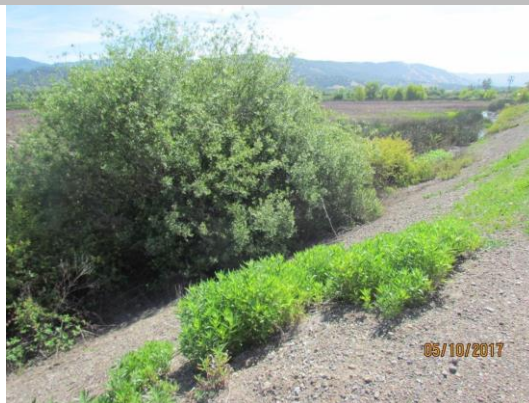
Photo 1 of 1 : SP_2018_MA0017_339_25_20180305_00006.jpg

View of the trees along the landside toe.

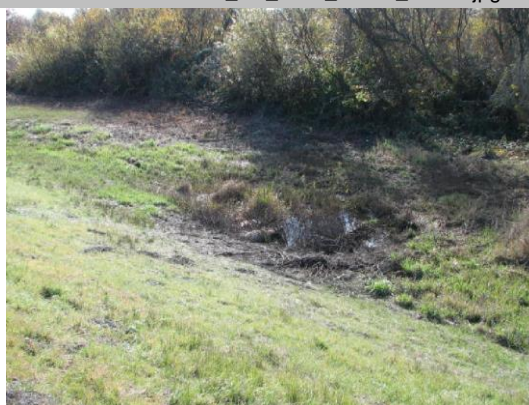
Photo 1 of 3 : UCIP_SP_2018_50814_46849.jpg

Comment Code					
Inspector Comment					
FS_ID:50814 DS_ID:844 EP_NO: 11463 Repair Type: No Action Needed Crossing Status: Found UCIP Comments: 10/19/2016 Crossing appears to be in good ondition. (DWR Sutter Yard- A/Freitag)6/14/2016 crossing appears to be in good condition.4/23/2015 No issues with pipe.7/3/2014 Same as last inspection.12/23/2013 Same as last inspection.8/2/2013 New flap gate installed. No other issues with pipe. FIELD_STRUCT_DESC: 24-inch corrugated metal drainage pipe through the levee, 12.4 feet below the crown. Flap gate on the waterside (WS) end. Timber walkway on the landside (LS) slope to a timber walkway to pump house mounted on piles in drainage ditch. (24- inch pipe [HLM 3.99] authorized under Automatic Board Order (ABO) issued as Permit No. 11463, 1975 - Audrey Jones). [Additional Reference(s): DWR Levee Log, 2005. USACE Sacramento O&M Manual 506.2, August 1961, (HLM 3.99)]. FS Date: 11/21/2016 12:09:38 PM

24-inch CMP at outlet on WS toe.

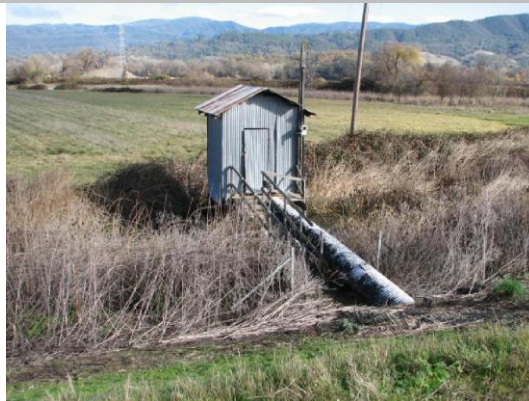
Photo 2 of 3 : UCIP_SP_2018_50814_46848.jpg

FS_ID:50814
DS_ID:844
EP_NO: 11463
Repair Type: No Action Needed
Crossing Status: Found
UCIP Comments: 10/19/2016 Crossing appears to be in good ondition.
(DWR Sutter Yard- A Freitag) 6/14/2016 crossing appears to be in good condition. 4/23/2015 No issues with pipe. 7/3/2014 Same as last inspection. 12/23/2013 Same as last inspection. 8/2/2013 New flap gate installed. No other issues with pipe.
FIELD_STRUCT_DESC: 24-inch corrugated metal drainage pipe through the levee, 12.4 feet below the crown. Flap gate on the waterside (WS) end. Timber walkway on the landside (LS) slope to a timber walkway to pump house mounted on piles in drainage ditch. (24-inch pipe [HLM 3.99] authorized under Automatic Board Order (ABO) issued as Permit No. 11463, 1975 - Audrey Jones). [Additional Reference(s): DWR Levee Log, 2005. USACE Sacramento O&M Manual 506.2, August 1961, (HLM 3.99)].
FS Date: 11/21/2016 12:09:38 PM

Pumphouse on piles at LS toe.

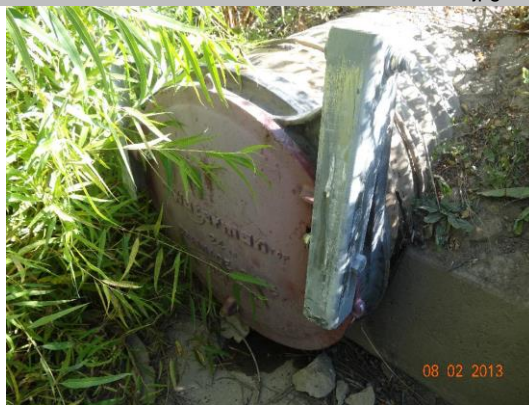
Photo 3 of 3 : UCIP_SP_2018_50814_46850.jpg

New flap gate on WS

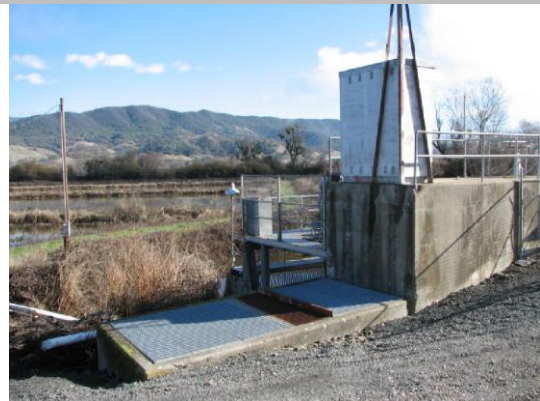
Photo 1 of 3 : UCIP_SP_2018_50815_46853.jpg

Comment Code					
Inspector Comment					
FS_ID:50815 DS_ID:845 EP_NO: 11464 Repair Type: No Action Needed Crossing Status: Found UCIP Comments: 10/27/2017 This structure is inspected annually under the Structure and Channel Summer Inspection (part of the Levee Inspection Program) conducted by the DWR Flood Project Integrity and Inspection Branch (FPIIB). (DWR UCIP - O. Magana) 10/19/2016 Crossing appears to be in good condition. (DWR Sutter Yard- A Freitag)6/14/2016 crossing appears to be in goiid condition.4/23/2015 No issues with pipe.7/3/2014 Same as last inspection.12/23/2013 Same as last inspection.8/2/2013 Same as last inspection. FIELD_STRUCT_DESC: [Bloody Island Pumping Plant] 1 of 2: 42-inch corrugated metal drainage pipe through the levee, 20.2 feet below the crown. Concrete headwall and discharge apron on the waterside (WS) shoulder. Three vertical pump units mounted on a reinforced concrete pump platform in drainage ditch at the landside (LS) toe. Flap gates in concrete discharge well on the LS. Combination flap and slide gate on a gravity pipe from drainage ditch into discharge well. (two 42-inch pipes [HLM 4.18] authorized under Automatic Board Order (ABO) issued as Permit No. 11464, 1975 - Lake County). [Additional Reference(s): DWR Levee Log, 2005. USACE Sacramento O&M Manual 506.2, August 1961, (HLM 4.18)]. FS Date: 11/21/2016 12:10:29 PM

Pumping Plant on LS shoulder.

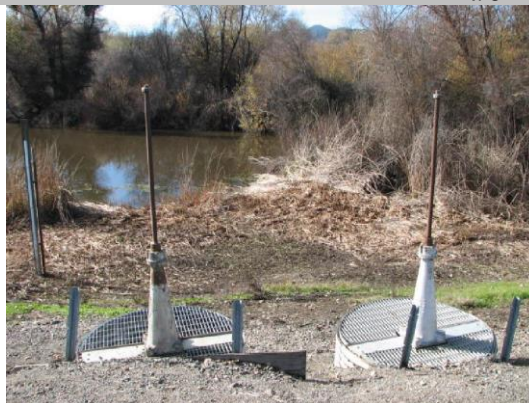
Photo 2 of 3 : UCIP_SP_2018_50815_46852.jpg

FS_ID:50815
DS_ID:845
EP_NO: 11464
Repair Type: No Action Needed
Crossing Status: Found
UCIP Comments: 10/27/2017 This structure is inspected annually under the Structure and Channel Summer Inspection (part of the Levee Inspection Program) conducted by the DWR Flood Project Integrity and Inspection Branch (FPIIB). (DWR UCIP - O. Magana)
10/19/2016 Crossing appears to be in good condition. (DWR Sutter Yard- A Freitag) 6/14/2016 crossing appears to be in good condition. 4/23/2015 No issues with pipe. 7/3/2014 Same as last inspection. 12/23/2013 Same as last inspection. 8/2/2013 Same as last inspection.
FIELD_STRUCT_DESC: [Bloody Island Pumping Plant] 1 of 2: 42-inch corrugated metal drainage pipe through the levee, 20.2 feet below the crown. Concrete headwall and discharge apron on the waterside (WS) shoulder. Three vertical pump units mounted on a reinforced concrete pump platform in drainage ditch at the landside (LS) toe. Flap gates in concrete discharge well on the LS. Combination flap and slide gate on a gravity pipe from drainage ditch into discharge well. (two 42-inch pipes [HLM 4.18] authorized under Automatic Board Order (ABO) issued as Permit No. 11464, 1975 - Lake County). [Additional Reference(s): DWR Levee Log, 2005. USACE Sacramento O&M Manual 506.2, August 1961, (HLM 4.18)].

Slide gates in CMP risers on WS shoulder.

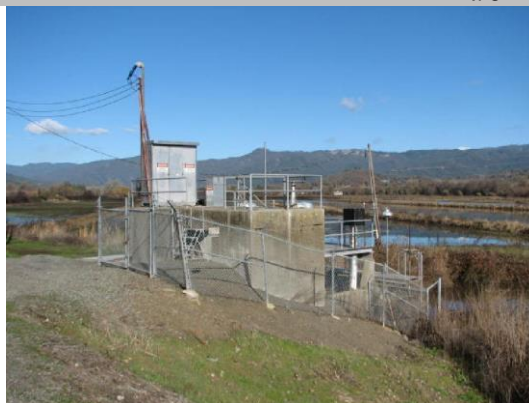
Photo 3 of 3 : UCIP_SP_2018_50815_46851.jpg

Pumping Plant on LS shoulder.

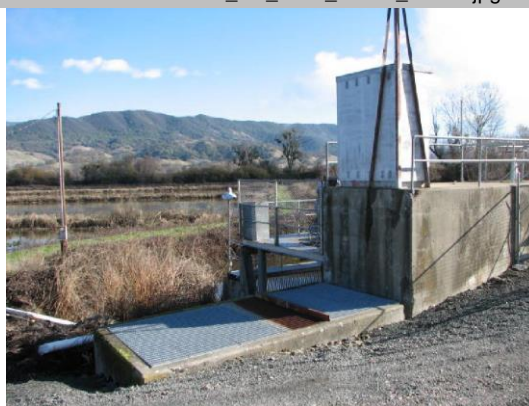
Photo 1 of 3 : UCIP_SP_2018_50816_46856.jpg

Comment Code					
Inspector Comment					
FS_ID:50816 DS_ID:852 EP_NO: 11464 Repair Type: No Action Needed Crossing Status: Found UCIP Comments: 10/27/2017 This structure is inspected annually under the Structure and Channel Summer Inspection (part of the Levee Inspection Program) conducted by the DWR Flood Project Integrity and Inspection Branch (FPIIB). (DWR UCIP - O. Magana) 10/19/2016 Crossing appears to be in good condition. (DWR Sutter Yard- A Freitag)6/14/2016 crossing appears to be in goioid condition.4/23/2015 No issues with pipe.7/3/2014 Same as last inspection.12/23/2013 Same as last inspection.8/2/2013 Same as last inspection. FIELD_STRUCT_DESC: [Bloody Island Pumping Plant] 2 of 2: 42-inch corrugated metal drainage pipe through the levee, 14.6 feet below the crown. Concrete headwall and discharge apron on the waterside (WS) shoulder. Three vertical pump units mounted on a reinforced concrete pump platform in drainage ditch at the landside (LS) toe. Flap gates in concrete discharge well on the LS. Combination flap and slide gate on a gravity pipe from drainage ditch into discharge well. (two 42-inch pipes [HLM 4.18] authorized under Automatic Board Order (ABO) issued as Permit No. 11464, 1975 - Lake County). [Additional Reference(s): DWR Levee Log, 2005. USACE Sacramento O&M Manual 506.2, August 1961, (HLM 4.18)]. FS Date: 11/21/2016 12:11:01 PM

Pumping plant on LS shoulder.

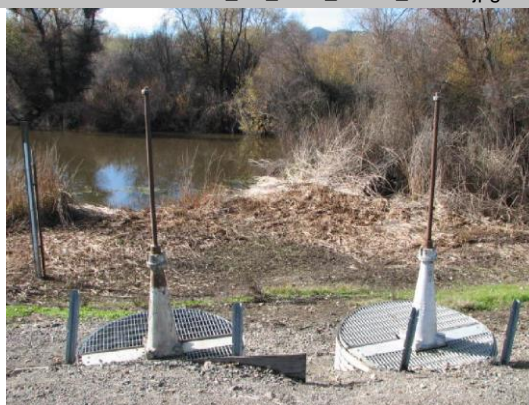
Photo 2 of 3 : UCIP_SP_2018_50816_46855.jpg

Slide gate in CMP riser on WS shoulder.

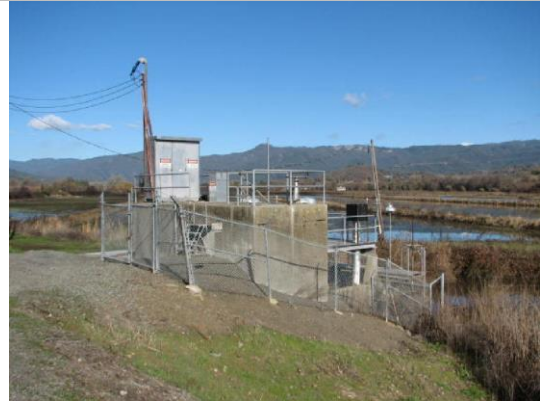
Photo 3 of 3 : UCIP_SP_2018_50816_46854.jpg

Comment Code						
Inspector Comment						
FS_ID:50816 DS_ID:852 EP_NO: 11464 Repair Type: No Action Needed Crossing Status: Found UCIP Comments: 10/27/2017 This structure is inspected annually under the Structure and Channel Summer Inspection (part of the Levee Inspection Program) conducted by the DWR Flood Project Integrity and Inspection Branch (FPIIB). (DWR UCIP - O. Magana) 10/19/2016 Crossing appears to be in good condition. (DWR Sutter Yard- A Freitag)6/14/2016 crossing appears to be in goioid condition.4/23/2015 No issues with pipe.7/3/2014 Same as last inspection.12/23/2013 Same as last inspection.8/2/2013 Same as last inspection. FIELD_STRUCT_DESC: [Bloody Island Pumping Plant] 2 of 2: 42-inch corrugated metal drainage pipe through the levee, 14.6 feet below the crown. Concrete headwall and discharge apron on the waterside (WS) shoulder. Three vertical pump units mounted on a reinforced concrete pump platform in drainage ditch at the landside (LS) toe. Flap gates in concrete discharge well on the LS. Combination flap and slide gate on a gravity pipe from drainage ditch into discharge well. (two 42-inch pipes [HLM 4.18] authorized under Automatic Board Order (ABO) issued as Permit No. 11464, 1975 - Lake County). [Additional Reference(s): DWR Levee Log, 2005. USACE Sacramento O&M Manual 506.2, August 1961, (HLM 4.18)]. FS Date: 11/21/2016 12:11:01 PM

Pumping plant on LS shoulder.

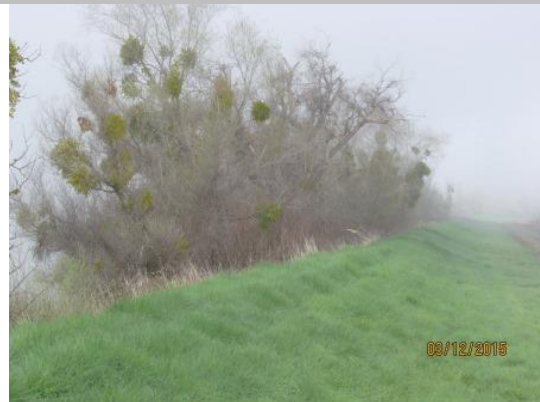
Photo 1 of 2 : SP_2018_MA0017_339_2_20180305_00001.jpg

LM Start	4.16	Rating **	U	Issue No.	2
LM End	7.10	Issue Type +	Ma	Location *	WS
Category	Earthen Levee			GPS Latitude/Longitude	
				Start	End
Item	Trim / Thin Trees			39.141894 °	39.120609 °
				-122.902201 °	-122.887166 °
DWR ID	DWR_MA0017_01_s_2012_2				
Comment Code					
T2 : Thin trees to allow visibility of the ground and room to flood fight.					
Inspector Comment					
Trees and limbs are completely obstructing visibility on crown and WS. Crown is too narrow to drive, and overgrown with weeds, brush and trees. Road follows LS toe.

View of the trees along the waterside slope and toe.

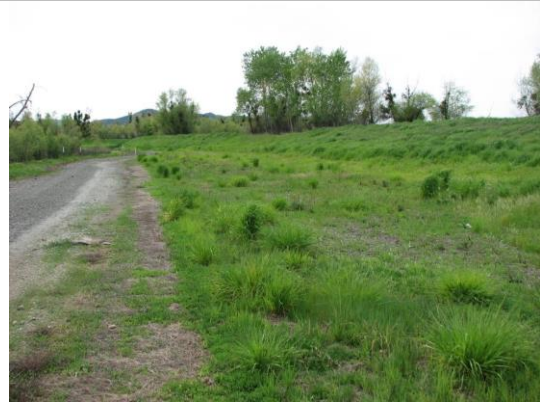
Photo 2 of 2 : SP_2018_MA0017_339_2_20180305_00002.jpg

Photo taken at LM 6.41 looking west showing overgrown LS slope of levee at right and toe road at left. Note trees obstructing visibility and access at levee crown. Crown is +/- 5 feet wide, and impassible to vehicles due to vegetation, and in some places, to pedestrians.
4/19/2016

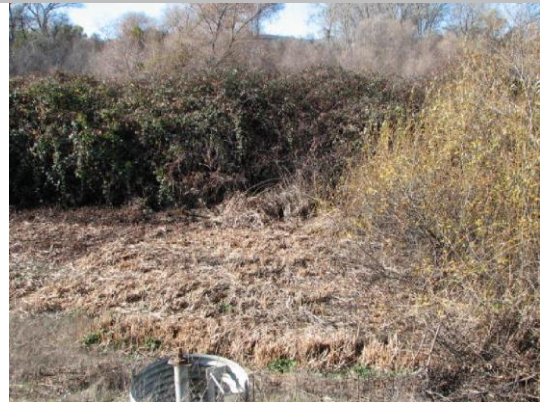
Photo 1 of 2 : UCIP_SP_2018_50817_46858.jpg

Comment Code					
Inspector Comment					
FS_ID:50817 DS_ID:846 EP_NO: 11462 Repair Type: Non-Urgent Crossing Status: Found UCIP Comments: 10/19/2016 No riser lid or slide gate wheel. (DWR Sutter Yard- AFreitag)6/14/2016 No riser lid and no wheel to operate screw gate.4/23/2015 Still no lid on riser and wheel to operate slide gate is missing.7/3/2014 Same as last inspection.12/23/2013 Same as last inspection.8/2/2013 Same as last inspection.12/13/2012 No lid on riser-may or may not be an issue. FIELD_STRUCT_DESC: 24-inch corrugated metal drainage pipe through the levee, 19 feet below the crown. Slide gate in 36-inch corrugated metal pipe (CMP) riser on the waterside (WS) slope. (Automatic Board Order (ABO) issued as Permit No. 11462, 1975 - Hobson) [Additional Reference(s): DWR Levee Log, 2005]. FS Date: 11/21/2016 12:11:29 PM

Slide gate in CMP riser on WS slope.

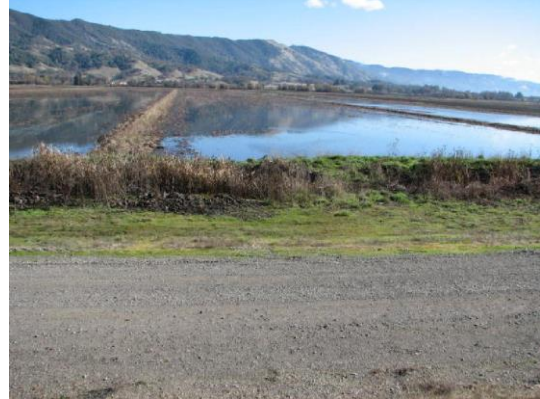
Photo 2 of 2 : UCIP_SP_2018_50817_46857.jpg

Comment Code						
Inspector Comment						
FS_ID:50817 DS_ID:846 EP_NO: 11462 Repair Type: Non-Urgent Crossing Status: Found UCIP Comments: 10/19/2016 No riser lid or slide gate wheel. (DWR Sutter Yard- AFreitag)6/14/2016 No riser lid and no wheel to operate screw gate.4/23/2015 Still no lid on riser and wheel to operate slide gate is missing.7/3/2014 Same as last inspection.12/23/2013 Same as last inspection.8/2/2013 Same as last inspection.12/13/2012 No lid on riser-may or may not be an issue. FIELD_STRUCT_DESC: 24-inch corrugated metal drainage pipe through the levee, 19 feet below the crown. Slide gate in 36-inch corrugated metal pipe (CMP) riser on the waterside (WS) slope. (Automatic Board Order (ABO) issued as Permit No. 11462, 1975 - Hobson) [Additional Reference(s): DWR Levee Log, 2005]. FS Date: 11/21/2016 12:11:29 PM

LS toe at approximate location of pipe inlet.

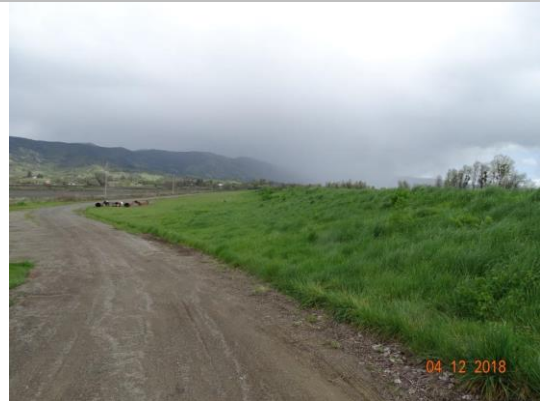
Photo 1 of 1 : SP_2018_MA0017_339_27_20180416_00045.jpg

LM Start	4.55	Rating **	M	Issue No.	27
LM End	7.29	Issue Type +	Ma	Location *	LS
Category	Earthen Levee			GPS Latitude/Longitude	
				Start	End
Item	Vegetation			39.136650 °	39.118672 °
				-122.900850 °	-122.884865 °
DWR ID	DWR_MA0017_01_s_2018_27				
Comment Code					
V1 : Control annual grass and weeds on the levee slopes and easements.					
Inspector Comment					
Remove the native vegetation from the landside slope.

View of the levee with native vegetation over 1 foot tall.

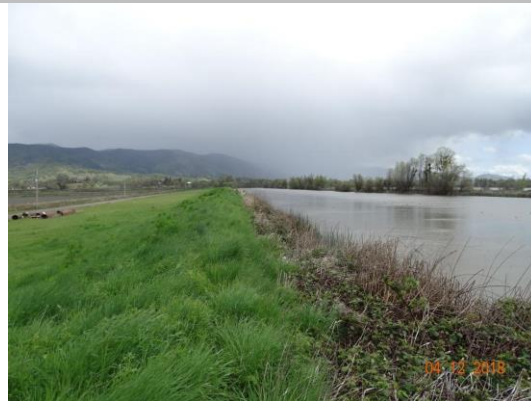
Photo 1 of 1 : SP_2018_MA0017_339_28_20180416_00046.jpg

View of the vegetation on the crown and waterside slope.

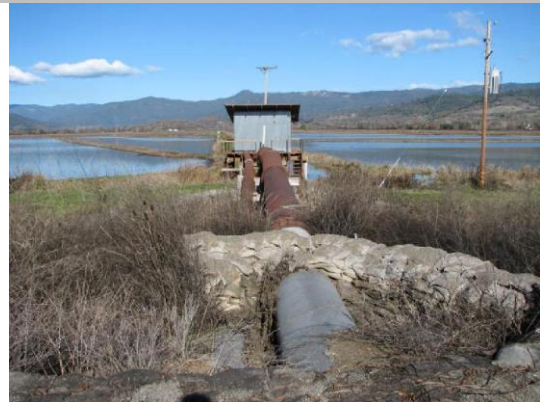
Photo 1 of 2 : UCIP_SP_2018_50818_46860.jpg

Comment Code					
Inspector Comment					
FS_ID:50818					
DS_ID:847					
EP_NO: 11469					
Repair Type: Non-Urgent					
Crossing Status: Found					
UCIP Comments: 10/19/2016 Sack ring still in place. (DWR Sutter Yard- A Freitag)6/14/2016 Sack ring is still built up underneath the pipes.4/23/2015 Sack ring is still built up underneath the pipes.7/3/2014 Same as last inspection.12/23/2013 Same as last inspection.8/2/2013 Same as last inspection.12/13/2012 flood fight materials-ring levees around both LS and WS slopes at pipe crossing. This may or may not be an issue.					
FIELD_STRUCT_DESC: 1 of 2: 16-inch steel drainage pipe through the levee, 5 feet below the crown. Drainage pumping plant on the landside (LS). Flap gate on the waterside (WS) end. (one 16-inch and one 36-inch pipes [HLM 5.43] authorized under Automatic Board Order (ABO) issued as Permit No. 11469, 1975 - RD 2070). [Additional Reference(s): DWR Levee Log, 2005. USACE Sacramento O&M Manual 506.3, August 1961, (HLM 5.43)].

Pumping plant, pipes, and ring levees on LS toe.

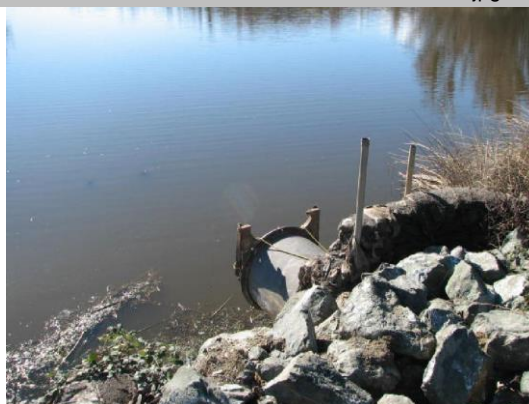
Photo 2 of 2 : UCIP_SP_2018_50819_46863.jpg

Pipe, flap gate, air vent, and sandbags on WS slope.

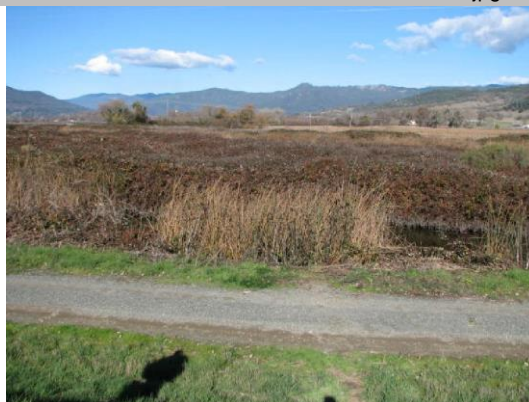
Photo 2 of 2 : UCIP_SP_2018_50820_46865.jpg

Approximate location of inlet on LS toe (not visible).

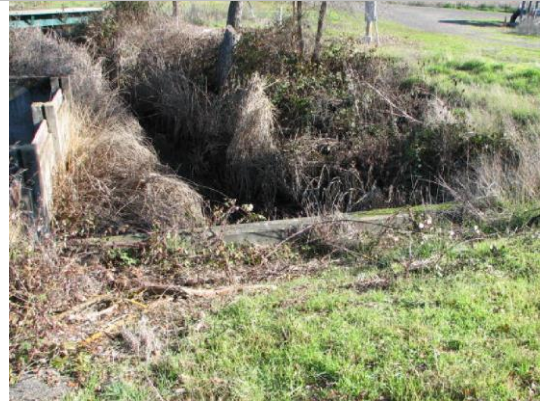
Photo 1 of 3 : UCIP_SP_2018_50821_46869.jpg

Comment Code						
Inspector Comment						
FS_ID:50821 DS_ID:849 EP_NO: 11467 Repair Type: No Action Needed Crossing Status: Found UCIP Comments: 10/27/2017 This structure is inspected annually under the Structure and Channel Summer Inspection (part of the Levee Inspection Program) conducted by the DWR Flood Project Integrity and Inspection Branch (FPIIB). (DWR UCIP - O. Magana) 10/19/2016 Crossing appears to be in good condition. (DWR Sutter Yard- A Freitag)6/14/2016 Flap gate propped open. Will make sure its closed before flood season.4/23/2015 Flap gate propped open. Not an issue at this time. Will close it before high water season.7/3/2014 Same as last inspection12/23/2013 Same as last inspection.8/2/2013 Same as last inspection. FIELD_STRUCT_DESC: [Highland Canal Diversion Weir and Drainage] 1 of 2: 54-inch corrugated metal drainage pipe through the levee 11.5 feet below the crown. Highland Canal Diversion Weir and Drainage Structure on the landside (LS). Concrete headwall on both landside (LS) and waterside (WS) toe with flap gate on the WS toe. (two 42-inch pipes [HLM 6.05] authorized under Automatic Board Order (ABO) issued as Permit No. 11467, 1975 - Modglin). [Additional Reference(s): DWR Levee Log, 2005. USACE Sacramento O&M Manual 506.3, August 1961, (HLM 6.05)]. FS Date: 11/21/2016 12:13:32 PM

Concrete weir/dam and channel on LS toe.

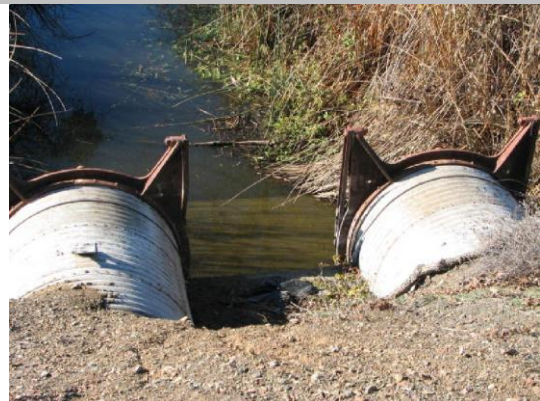
Photo 2 of 3 : UCIP_SP_2018_50821_46868.jpg

pipe and flap gate on WS toe.

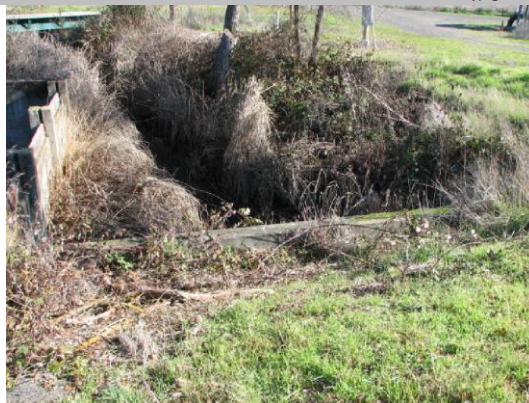
Photo 1 of 3 : UCIP_SP_2018_50822_46872.jpg

FS_ID:50822
 DS_ID:854
 EP_NO: 11467
 Repair Type: No Action Needed
 Crossing Status: Found
 UCIP Comments: 10/27/2017 This structure is inspected annually under the Structure and Channel Summer Inspection (part of the Levee Inspection Program) conducted by the DWR Flood Project Integrity and Inspection Branch (FPIIB). (DWR UCIP - O. Magana)
 10/19/2016 Crossing appears to be in good condition. (DWR Sutter Yard- A Freitag) 6/14/2016 Flap gate propped open. Will make sure its closed before flood season. 4/23/2015 Flap gate propped open. Not an issue at this time. Will close it before high water season. 7/3/2014 Same as last inspection. 12/23/2013 Same as last inspection. 8/2/2013 Same as last inspection.
 FIELD_STRUCT_DESC: [Highland Canal Diversion Weir and Drainage]
 2 of 2: 54-inch corrugated metal drainage pipe through the levee, 11.5 feet below the crown Highland Canal Diversion Weir and Drainage Structure on the landside (LS). Concrete headwall on both landside (LS) and waterside (WS) toe with flap gate on the WS toe. (two 42-inch pipes [HLM 6.05] authorized under Automatic Board Order (ABO) issued as Permit No. 11467, 1975 - Modglin). [Additional Reference(s): DWR Levee Log, 2005. USACE Sacramento O&M Manual 506.3, August 1961, (HLM 6.05)].

Concrete dam/weir and channel on LS toe.

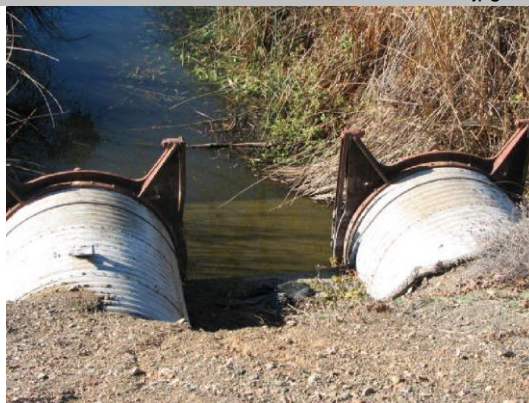
Photo 2 of 3 : UCIP_SP_2018_50822_46871.jpg

Pipe and flap gate on WS toe.

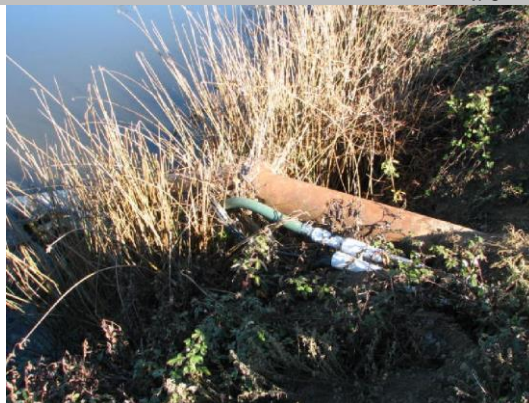
Photo 1 of 3 : UCIP_SP_2018_50824_46878.jpg

Comment Code						
Inspector Comment						
FS_ID:50824 DS_ID:20587 EP_NO: N/A Repair Type: Urgent Crossing Status: Found UCIP Comments: 10/19/2016 WS erosion still present. (DWR Sutter Yard- AFreitag)6/14/2016 WS erosoin is still present. (DWR Sutter Yard - aFreitag)4/23/2015 Erosion on WS shoulder is still present. (DWR Sutter Yard - aFreitag)7/3/2014 Same as last inspection. (DWR Sutter Yard - aFreitag)12/23/2013 Same as last inspection. (DWR Sutter Yard - aFreitag)8/2/2013 Erosion on WS shoulder above pipes. (DWR Sutter Yard - aFreitag)12/13/2012 No permit for this crossing. This is a primer line, used to fill up main pipe before its pump is turned on (Permit No. 11467). (DWR UCIP - wwylie) FIELD_STRUCT_DESC: 4-inch polyvinyl chloride (PVC) conduit of an unknown purpose through the levee, 2 feet below the crown, with plastic pipe running through it to pump on the landside (LS). No permit has been identified since crossing was field discovered in 2012. FS Date: 11/21/2016 12:15:33 PM

4-inch pvc pipe with green flexible pipe running through it on WS shoulder.

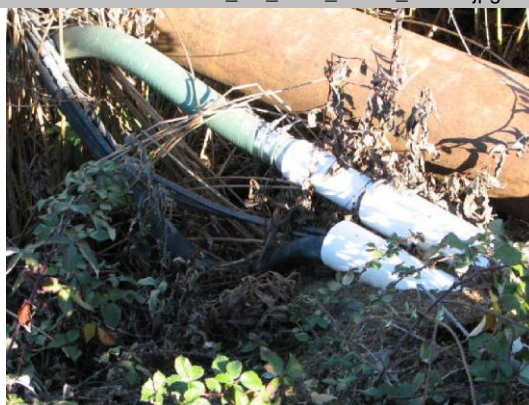
Photo 2 of 3 : UCIP_SP_2018_50824_46877.jpg

4-inch pvc pipe with green flexible pipe running through it on WS shoulder.

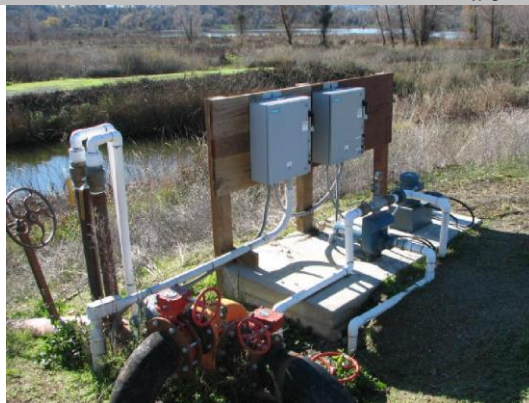
Photo 3 of 3 : UCIP_SP_2018_50824_46876.jpg

Comment Code						
Inspector Comment						
FS_ID:50824 DS_ID:20587 EP_NO: N/A Repair Type: Urgent Crossing Status: Found UCIP Comments: 10/19/2016 WS erosion still present. (DWR Sutter Yard- A Freitag)6/14/2016 WS erosoin is still present. (DWR Sutter Yard - afreitag)4/23/2015 Erosion on WS shoulder is still present. (DWR Sutter Yard - afreitag)7/3/2014 Same as last inspection. (DWR Sutter Yard - afreitag)12/23/2013 Same as last inspection. (DWR Sutter Yard - afreitag)8/2/2013 Erosion on WS shoulder above pipes. (DWR Sutter Yard - afreitag)12/13/2012 No permit for this crossing. This is a primer line, used to fill up main pipe before its pump is turned on (Permit No. 11467). (DWR UCIP - wwylie) FIELD_STRUCT_DESC: 4-inch polyvinyl chloride (PVC) conduit of an unknown purpose through the levee, 2 feet below the crown, with plastic pipe running through it to pump on the landside (LS). No permit has been identified since crossing was field discovered in 2012. FS Date: 11/21/2016 12:15:33 PM

LS pump station on shoulder.

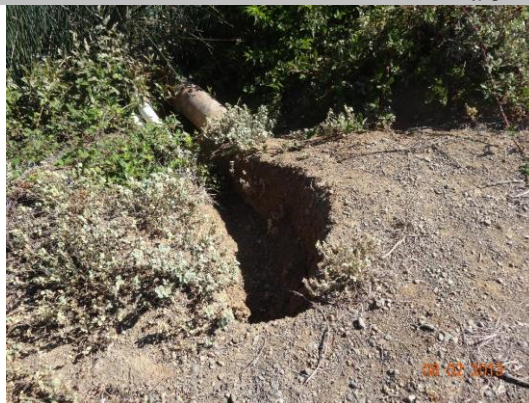
Photo 3 of 3 : UCIP_SP_2018_50825_46875.jpg

Comment Code						
Inspector Comment						
FS_ID:50825 DS_ID:20588 EP_NO: N/A Repair Type: Urgent Crossing Status: Found UCIP Comments: 10/19/2016 WS erosion still present. (DWR Sutter Yard- A Freitag)6/14/2016 WS erosion is still present. (DWR Sutter Yard - a Freitag)4/23/2015 Erosion still present on WS shoulder. (DWR Sutter Yard - a Freitag)7/3/2014 Same as last inspection. (DWR Sutter Yard - a Freitag)12/23/2013 Same as last inspection. (DWR Sutter Yard - a Freitag)8/2/2013 Erosion on WS shoulder above pipes. (DWR Sutter Yard - a Freitag)12/13/2012 No permit for this crossing. It is unclear what these hydraulic lines are for, but it is probably the works for a hydraulic butterfly valve at the outlet. (DWR UCIP - wwyliie) FIELD_STRUCT_DESC: 4-inch polyvinyl chloride (PVC) conduit of an unknown purpose through the levee, 2 feet below the crown, with hydraulic lines running through it to pump on the landside (LS) shoulder. No permit has been identified since crossing was field discovered in 2012. FS Date: 11/21/2016 12:16:01 PM

Erosion on WS shoulder

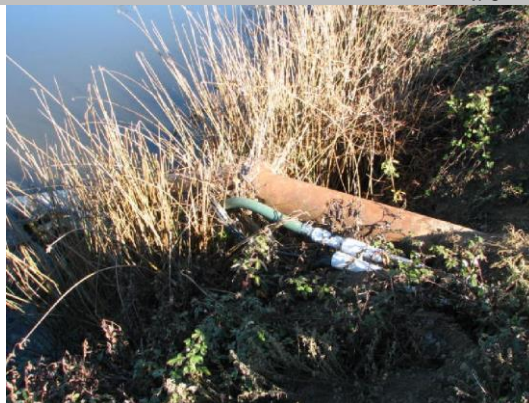
Photo 1 of 3 : UCIP_SP_2018_50826_46882.jpg

Comment Code					
Inspector Comment					
FS_ID:50826 DS_ID:850 EP_NO: 11467 Repair Type: Urgent Crossing Status: Found UCIP Comments: 10/19/2016 WS erosion still present. (DWR Sutter Yard- A Freitag)6/14/2016 WS erosion is still present. (DWR Sutter Yard - a Freitag)4/23/2015 Same as last inspection. (DWR Sutter Yard - a Freitag)7/3/2014 Same as last inspection. (DWR Sutter Yard - a Freitag)12/23/2013 Same as last inspection. (DWR Sutter Yard - a Freitag)8/2/2013 Same as last inspection. (DWR Sutter Yard - a Freitag)12/13/2012 This pipe and appurtenances do not match what was described in the permit (PN: 11467). Does not appear to be in compliance with board regulations. (DWR UCIP - wwyllie) FIELD_STRUCT_DESC: 12-inch steel drainage pipe through the levee, 2 feet below the crown. Butterfly valve on the landside (LS) shoulder. Pump and electrical panel, along with multiple valves and appurtenances, on the LS shoulder. (12-inch pipe [HLM 6.11] authorized under Automatic Board Order (ABO) issued as Permit No. 11467, 1975 - B. F. Modglin[Additional Reference(s): DWR Levee Log, 2005. USACE Sacramento O&M Manual 506.3, 1967, (HLM 6.11)]. FS Date: 11/21/2016 12:16:25 PM

12-inch pipe and appurtenances on WS shoulder.

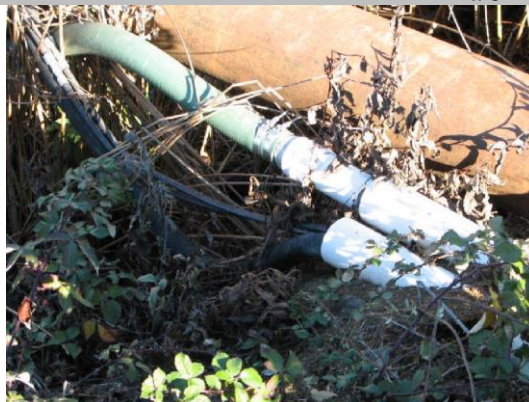
Photo 2 of 3 : UCIP_SP_2018_50826_46881.jpg

12-inch pipe and appurtenances on WS shoulder.

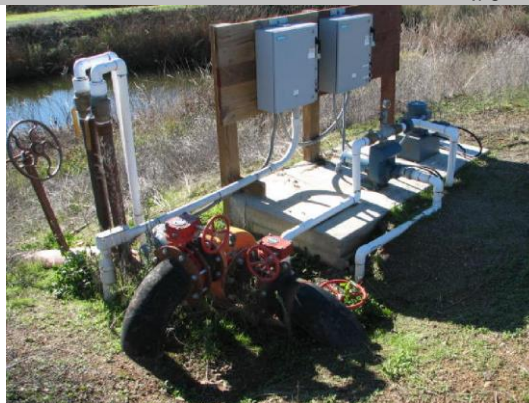
Photo 3 of 3 : UCIP_SP_2018_50826_46880.jpg

Comment Code						
Inspector Comment						
FS_ID:50826 DS_ID:850 EP_NO: 11467 Repair Type: Urgent Crossing Status: Found UCIP Comments: 10/19/2016 WS erosion still present. (DWR Sutter Yard- AFreitag)6/14/2016 WS erosion is still present. (DWR Sutter Yard - aFreitag)4/23/2015 Same as last inspection. (DWR Sutter Yard - aFreitag)7/3/2014 Same as last inspection. (DWR Sutter Yard - aFreitag)12/23/2013 Same as last inspection. (DWR Sutter Yard - aFreitag)8/2/2013 Same as last inspection. (DWR Sutter Yard - aFreitag)12/13/2012 This pipe and appurtances do not match what was described in the permit (PN: 11467). Does not appear to be in compliance with board regulations. (DWR UCIP - wwylie) FIELD_STRUCT_DESC: 12-inch steel drainage pipe through the levee, 2 feet below the crown. Butterfly valve on the landside (LS) shoulder. Pump and electrical panel, along with multiple valves and appurtenances, on the LS shoulder. (12-inch pipe [HLM 6.11] authorized under Automatic Board Order (ABO) issued as Permit No. 11467, 1975 - B. F. Modglin[Additional Reference(s): DWR Levee Log, 2005. USACE Sacramento O&M Manual 506.3, 1967, (HLM 6.11)]. FS Date: 11/21/2016 12:16:25 PM

Pumping plant and appurtances on LS shoulder.

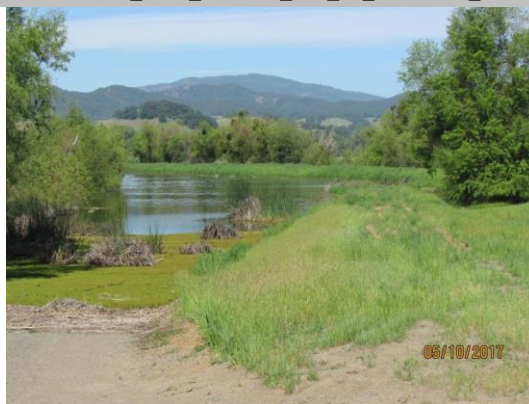
Photo 1 of 1 : SP_2018_MA0017_339_23_20180305_00005.jpg

LM Start	6.03	Rating **	U	Issue No.	23
LM End	7.28	Issue Type +	Ob	Location *	LS
Category	Earthen Levee			GPS Latitude/Longitude	
				Start	End
Item	Seepage / Sandboils			39.126045 °	39.118727 °
				-122.883828 °	-122.884842 °
DWR ID	DWR_MA0017_01_s_2017_23				
Comment Code					
Inspector Comment					
There was water along the landside slope so that area was unable to be inspected.

View of the water along the landside slope.

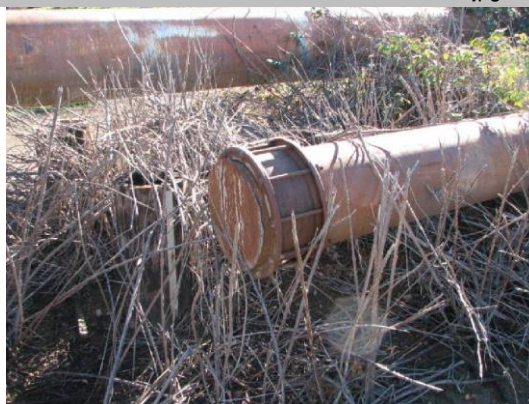
Photo 2 of 2 : UCIP_SP_2018_50827_46883.jpg

Steel plate welded over end of pipe at LS toe.

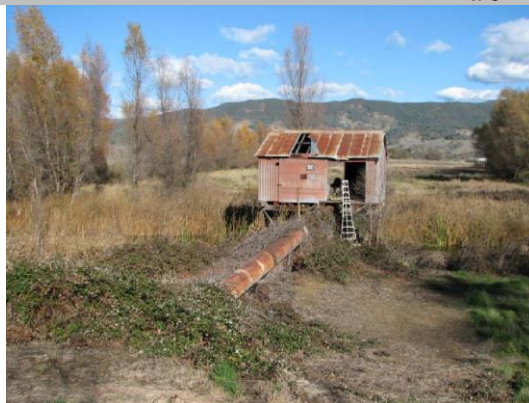
Photo 1 of 2 : UCIP_SP_2018_50828_46886.jpg

FS_ID:50828
DS_ID:855
EP_NO: 11467
Repair Type: No Action Needed
Crossing Status: Found
UCIP Comments: 10/19/2016 Crossing appears to be in good condition. (DWR Sutter Yard- A Freitag) 6/14/2016 Crossing appears to be in good condition. 4/23/2015 No issues seen with pipe. 7/3/2014 Same as last inspection. 8/2/2013 Same as last inspection. 12/23/2013 Same as last inspection.
FIELD_STRUCT_DESC: 2 of 2: 24-inch steel drainage pipe through the levee, 8 feet below the crown.
Drainage pumping plant on the landside (LS). Flap gate on the waterside (WS) end. (one 16-inch and one 24-inch pipes [HLM 7.79] authorized under Automatic Board Order (ABO) issued as Permit No. 11467, 1975 - Modglin) [Additional Reference(s): DWR Levee Log, 2005. USACE Sacramento O&M Manual 506.3, August 1961, (HLM 7.19)].
FS Date: 11/21/2016 12:17:36 PM

24-inch steel pipe and pump house on LS.

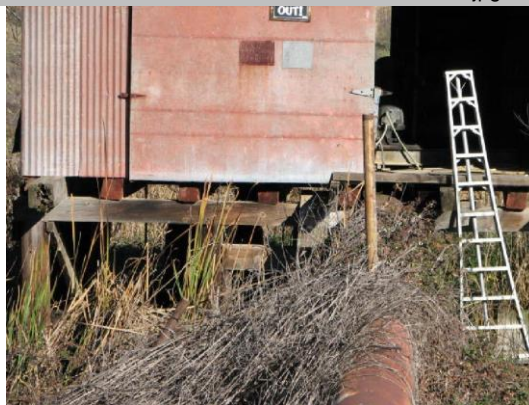
Photo 2 of 2 : UCIP_SP_2018_50828_46885.jpg

Air vent on pipe at LS pump house.
